An introduction to Occupational Hygiene

What is an Occupational Hygienist, and what do we do?

AFOEM Annual Training Meeting

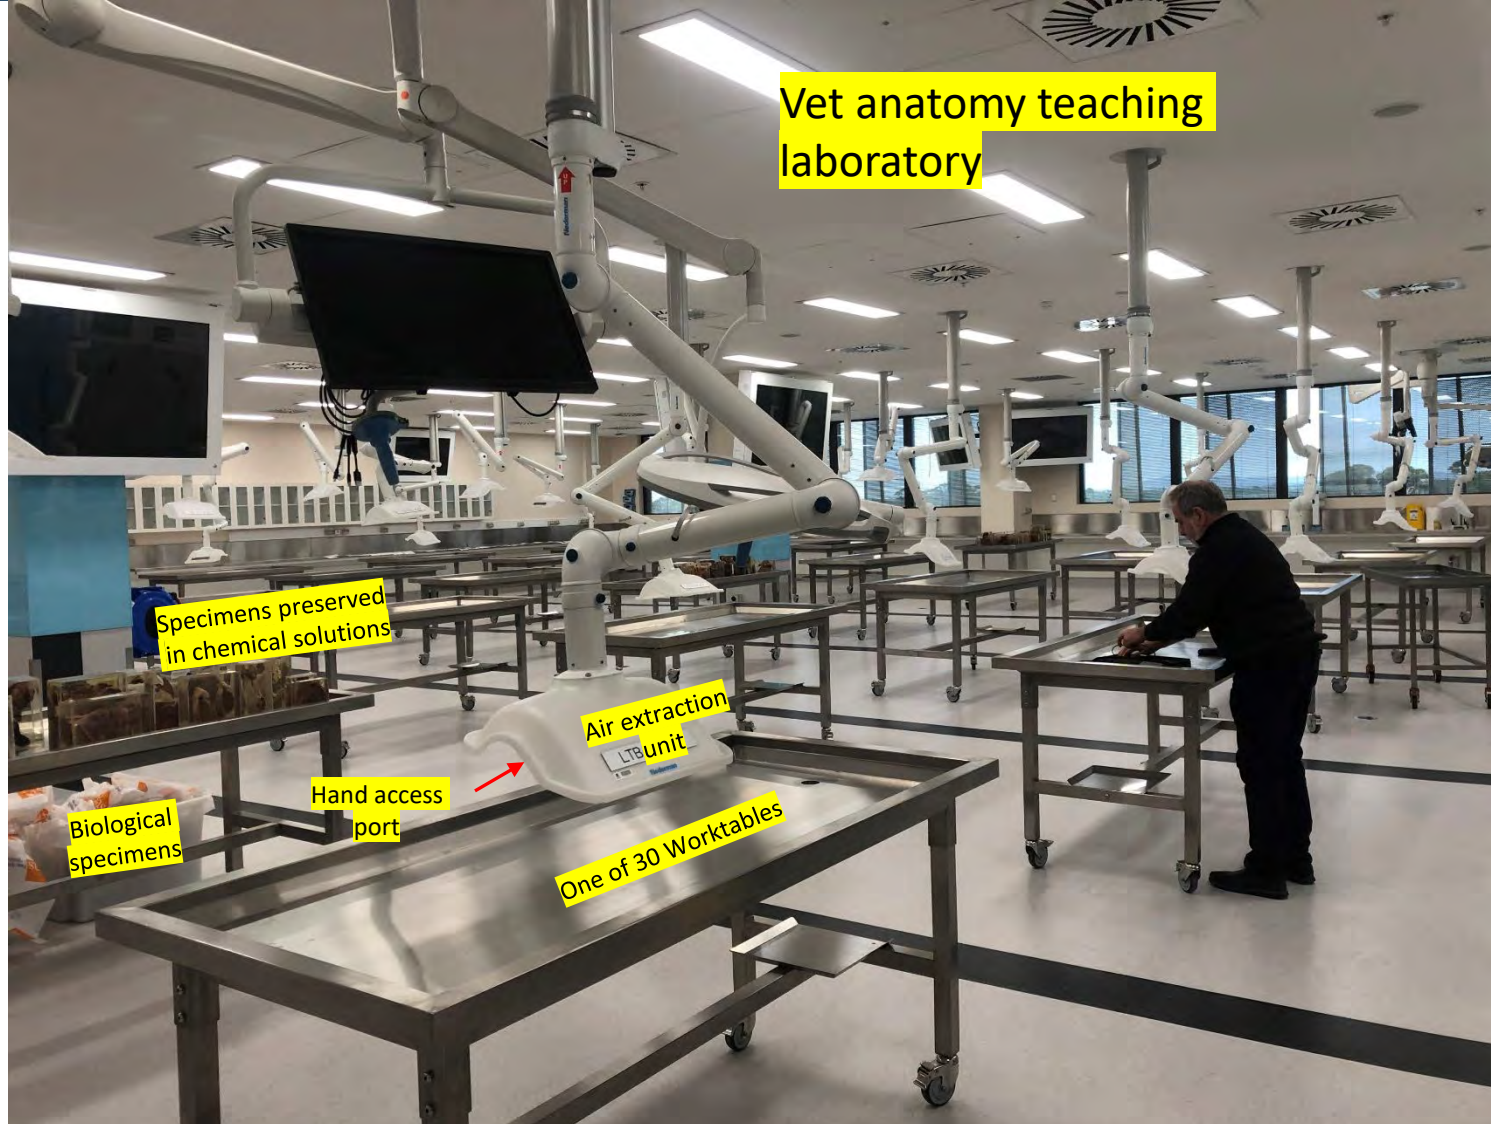
Vet anatomy teaching laboratory

Specimens preserved in chemical solutions

Biological specimens

Hand access port

Air extraction LTB unit

One of 30 Worktables

An idea would be to measure the extraction unit to see if it's working to an appropriate level?

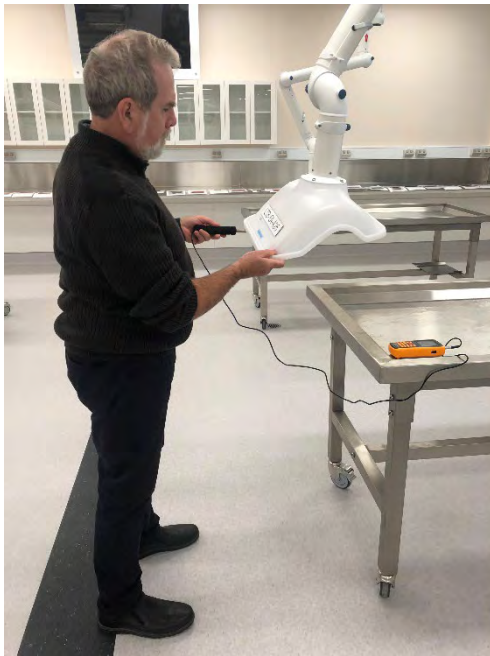
Is this extraction hood working for the student or against them?

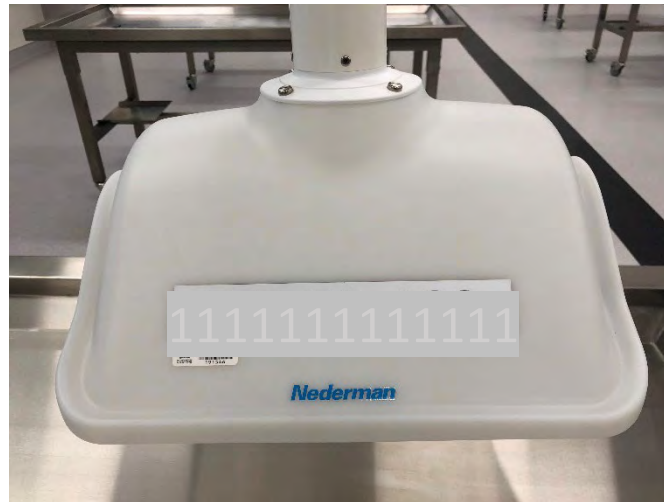
Hand access point

Do you think a transparent hood would be a better option?

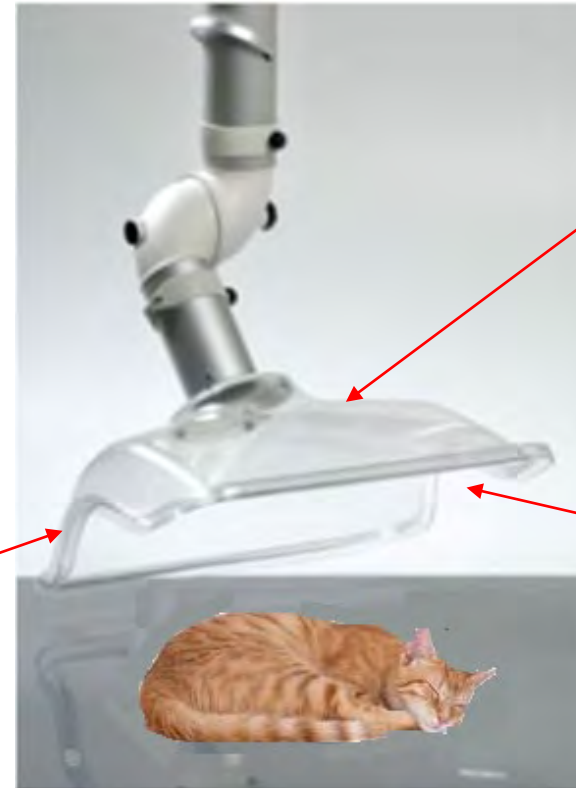
Transparent hood

Hand access point

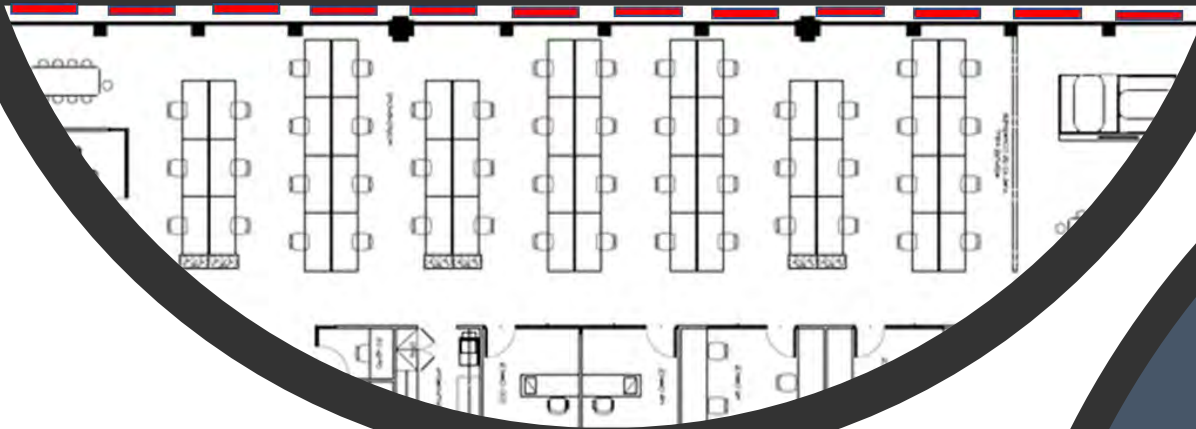
Slotted Linear Diffusers (SLD) positioned around the perimeter of the office

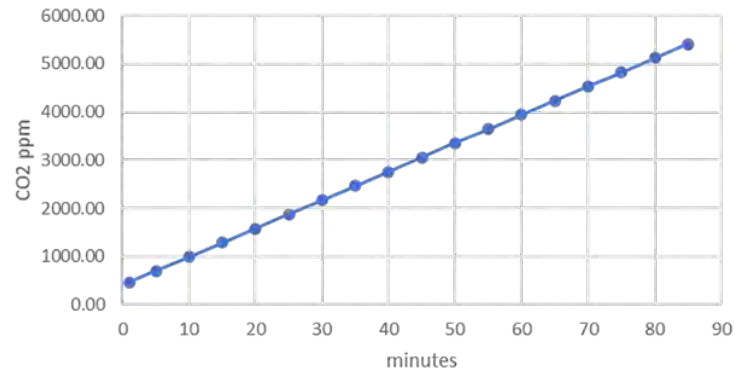
Carbon dioxide level in the office

CO2 trigger point= level Averaged over an 8-hour day = 850ppm

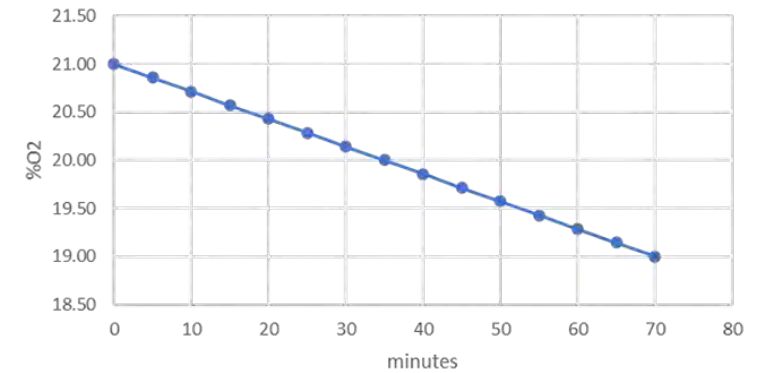
Oxygen level in the office

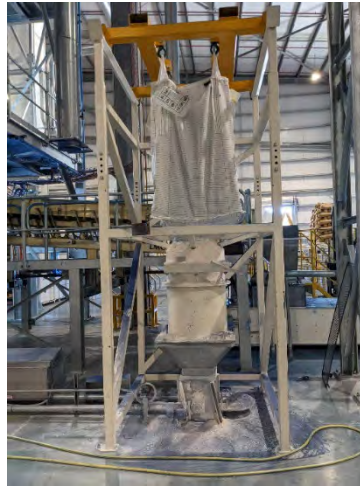
Fluency Agitator

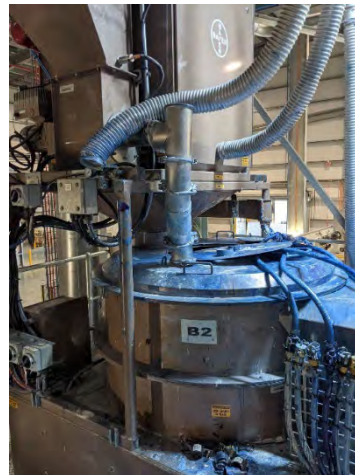
Treaters

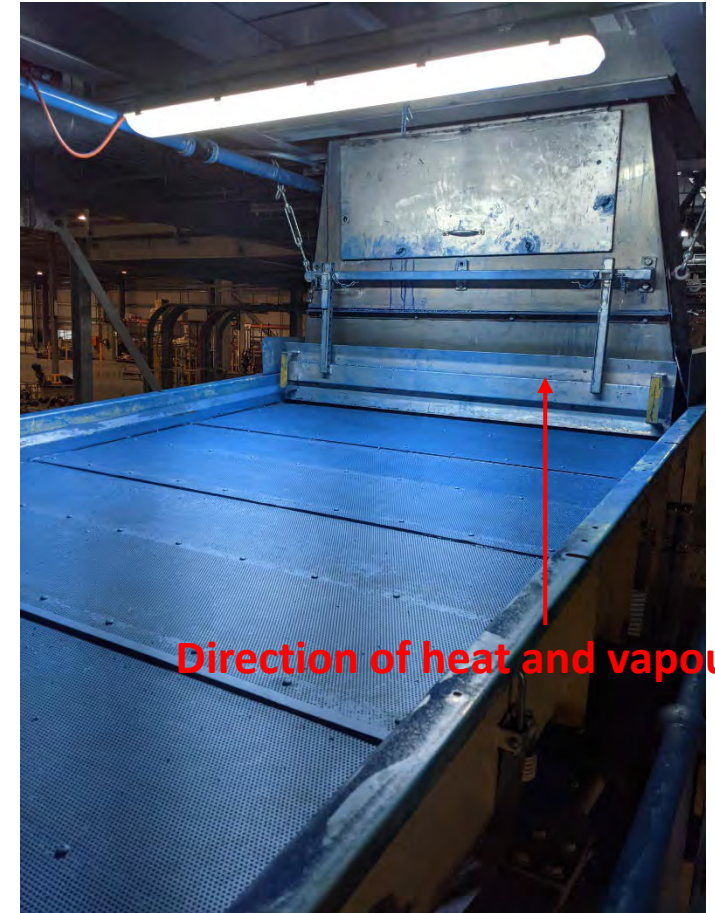
Drying tables

- Poor extraction along the drying table
- Only natural ventilation for the dilution of contaminants
- TriPlus was major cause to the health impacts of workers
- PPE not sufficiently adequate
- Decontamination procedure not adequate
- Work practices contributing to exposure of dusts, fumes or vapour
